Historic Structures Report

Benson's Property

Town of Hudson, New Hampshire

The Haselton Barn

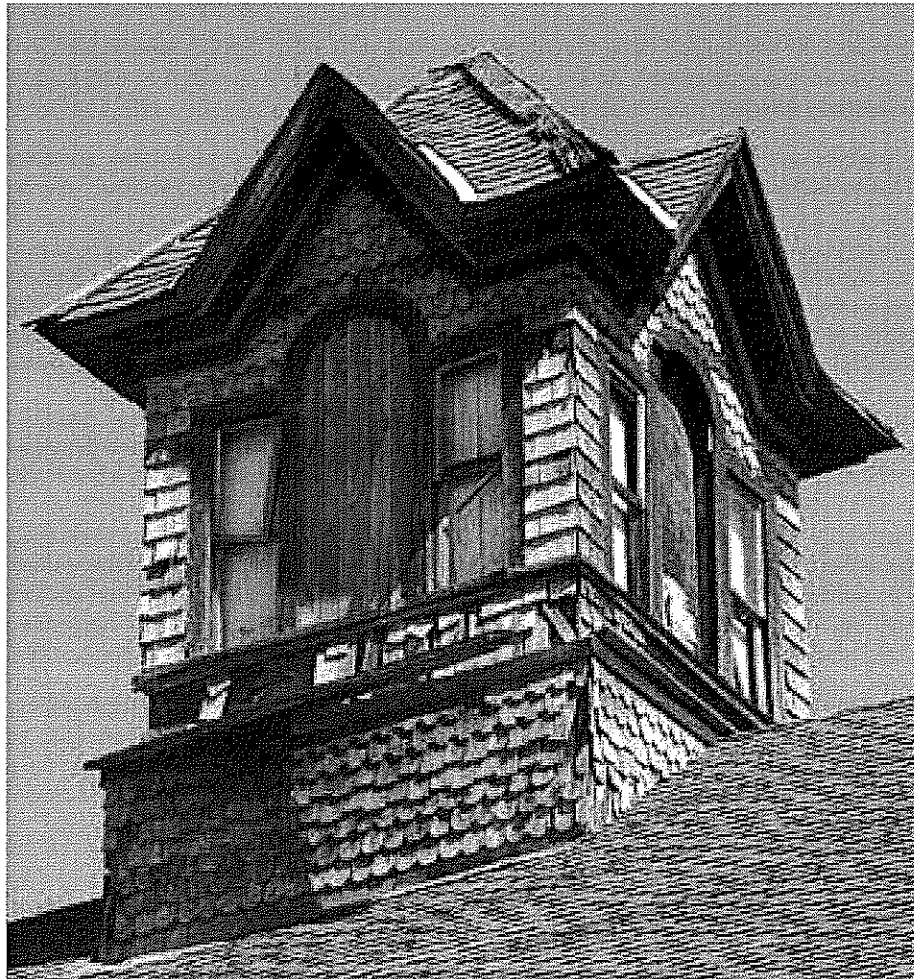
The most important immediate requirement to insure the preservation of the structure is stabilization. In particular, it was discovered that the cupola is in worse condition than anticipated. It is close to complete structural failure. Temporary removal of the cupola will allow repairs to be safely completed, so that it can be returned to the building in sound and maintainable condition.

Figure 10. Extensive deterioration of cupola. Photograph by John Butler. (May, 2003)

3. **Stabilize Cupola** – The cupola on top of the original barn is in significant structural failure. It should be stabilized and removed to the ground in order to reduce the risk of continued damage to its architectural and structural elements. The extent of damage here also poses a significant safety risk should strong wind and heavy snow aid in its imminent collapse. The cupola is the one element of the barn that is highly decorated. Upon placing the structure on the ground, it should be sheltered inside the cellar bay at the rear of the barn or covered by a temporary structure that will protect and secure it. The remaining roof opening atop the barn must be covered with a temporary roof designed to prevent continued water penetration into the structure. (The Benson's Committee has suggested that the cupola be removed to the Hudson Highway Maintenance Facility pending restoration and re-erection).
