Town Hall Renovations

TO: Board of Selectmen
FROM: Elvis Dhima, P.E., Town Engineer
DATE: October 29, 2024
RE: Town Hall Building Assessment Follow Up

RE: Town Hall Building Assessment Findings and Recommendations

This assessment, completed in September 2024, analyzed the existing spaces of the Hudson Town Hall building located on 12 School Street. The study provides a comprehensive report on the findings based on RFP dated May 10, 2024. In addition, provides recommendations to correct deficiencies with space, codes, ADA, adjacencies as well as recommendations to alternate solutions. Current codes and Local jurisdictions should be considered with the final layout/ solutions at the time of 'updates' to prevent further deficiencies.

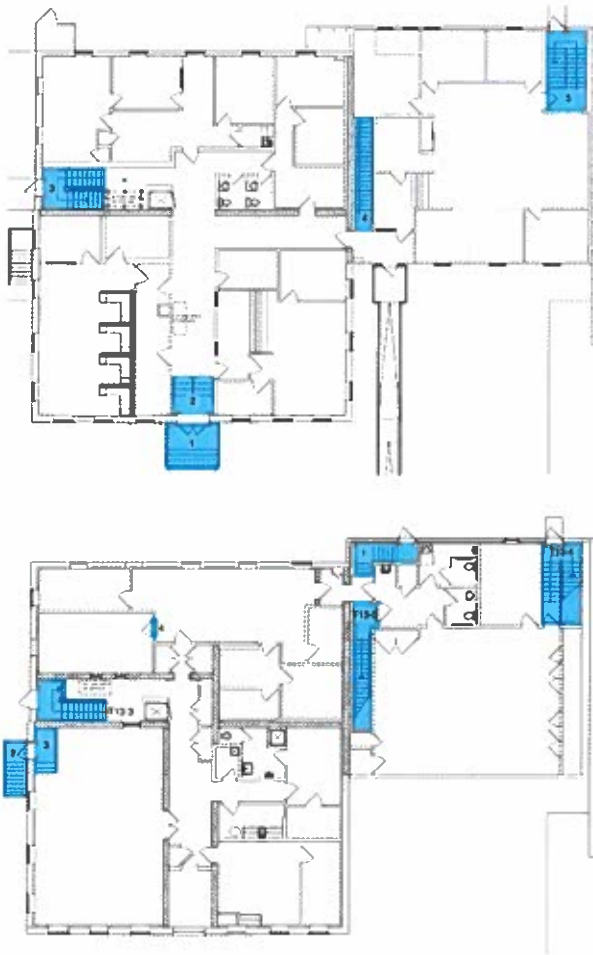
Table 3: Stair Dimensions

- **Stairs:** There are currently no areas within the building that are labeled/designated area of refuge required. The building is fully* sprinklered throughout. Several Stairs do not comply with full codes.
 - Consider adding area of refuge to areas to maintain clear hall egress – shown below in red
 - Consider addressing stairs with future remodel to comply with codes
 - Consider verifying Fire & Life Safety Coverage of sprinkler heads in *missing areas.

Stairs First Floor					
Space	Dimension (Width)		Riser Heights	# Risers	Tread
#1 stairs landing	10'-1"		7"	4	1'
	10'-1"	5'-0"	1	-	-
#2 Bottom landing Stairs	8'-0.5"	3'-8"	-	-	-
	8'-0.5"		Range from 7"-7.5"	3	1'-1.5"
#3 Top of stairs Landing Bottom of Stair	3'-10"		7"	18	11"
	4'-4"	8'-0"			
	3'-10"				
#4 Landing at top Stairs	3'-4.25"	4'-0"	-	-	-
	3'-4.25"		-	18	11"
#5 Top of stair Landing Bottom of Stair	3'-10.75"		-	18	11"
	3'-7"	7'-7"			
	3'-7.5"

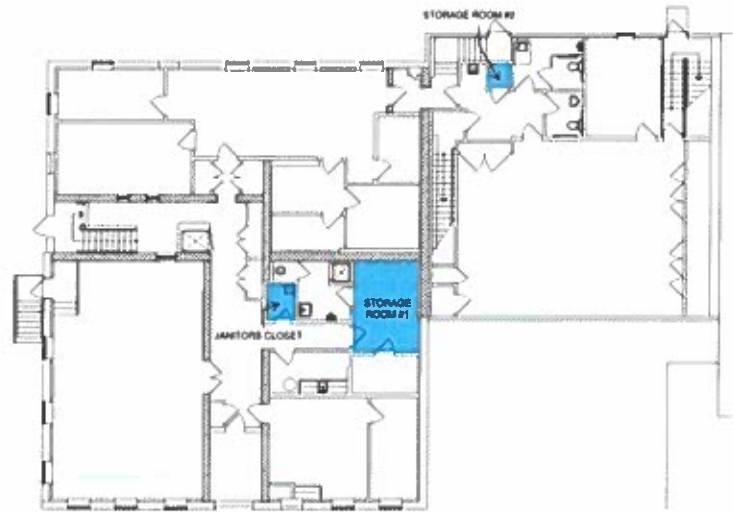
Table 12: Janitor Spaces

There are no standard requirements for these rooms.

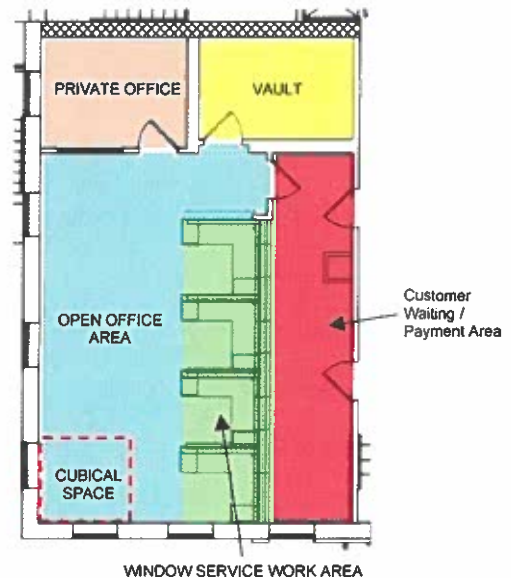
Table 10: Town Clerk/Tax Collector Department Square Footages

The Private Office adheres to the recommended square footage, falling within the Small Private Office range of 90-150 square feet as detailed in the enclosed Office Requirements shown in Appendix 1, and is classified as a High-Density Level office with 80-150 square feet per employee, according to Appendix 2.

The Window Service Area and Open Office Area falls within the Standard Cubicle Configurations range 16-120 square feet, as outlined in Appendix 3. The Window Service area however does not conform with the recommended requirements of 60-110 square feet per person. The window service areas are ADA compliant.

- **Private Office:** Meets the recommended square footage and density level requirements.
- **Vault:** Does not comply.
 - Consider installing a rolling high density storage filing system

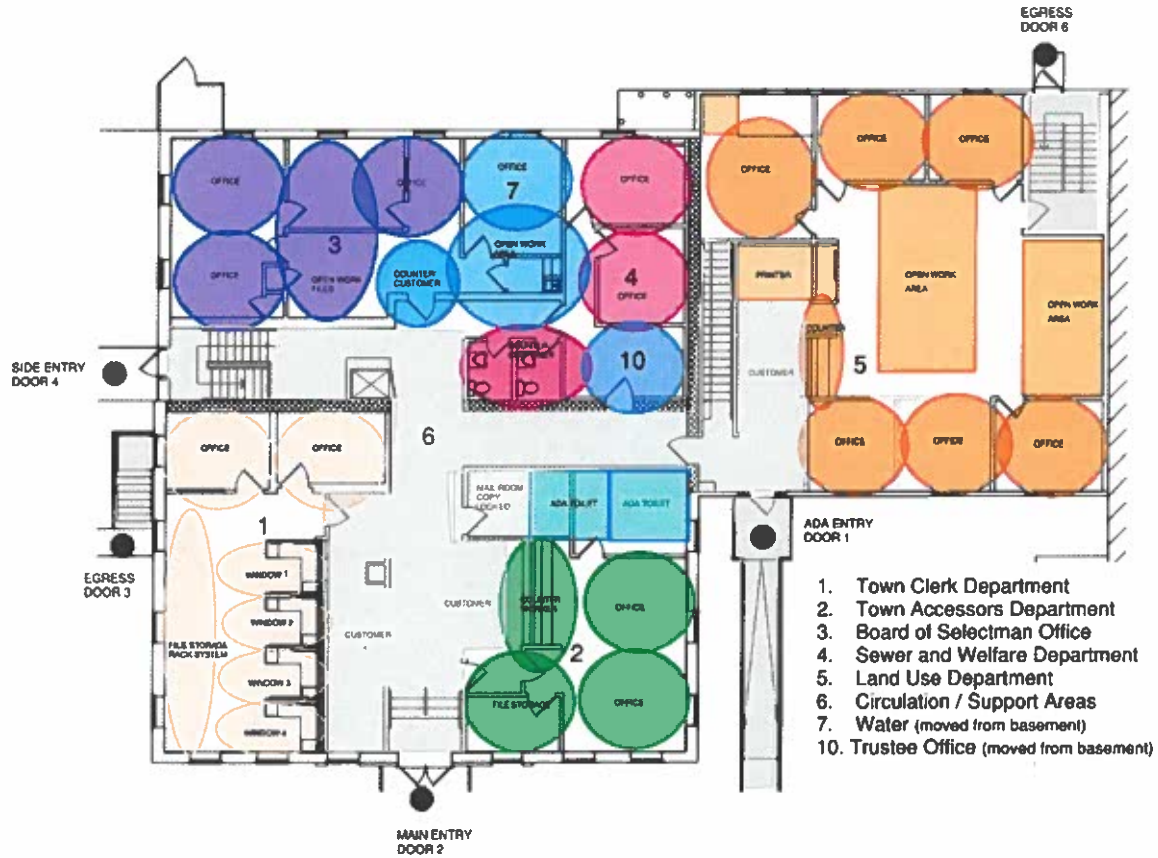
Proposed First Floor

Proposed Interior Remodel Option 1:

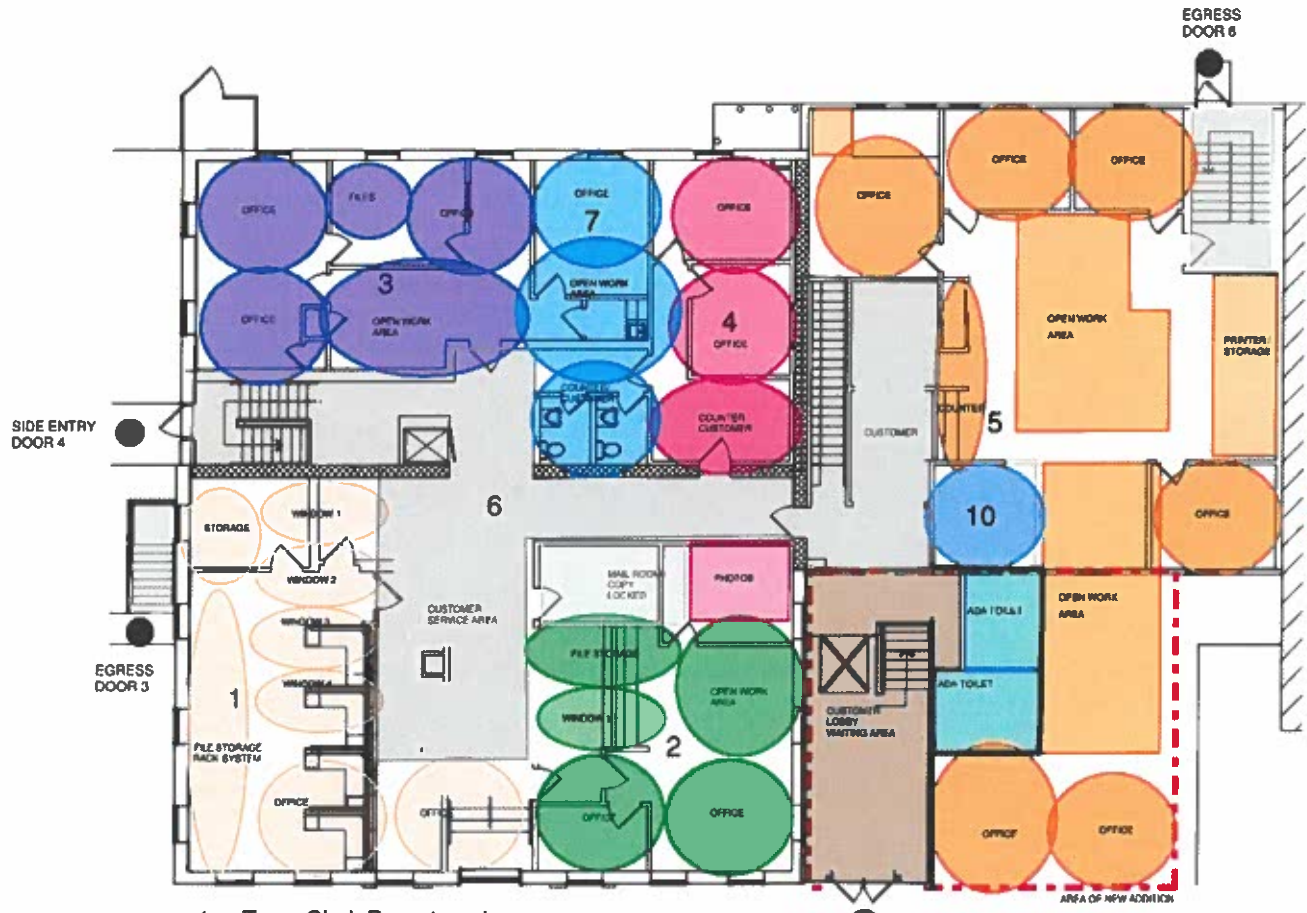
Proposed First Floor

- 1. Town Clerk Department
- 2. Town Accessors Department
- 3. Board of Selectman Office
- 4. Sewer and Welfare Department
- 5. Land Use Department
- 6. Circulation / Support Areas
- 7. Water (moved from basement)
- 10. Trustee Office (moved from basement)

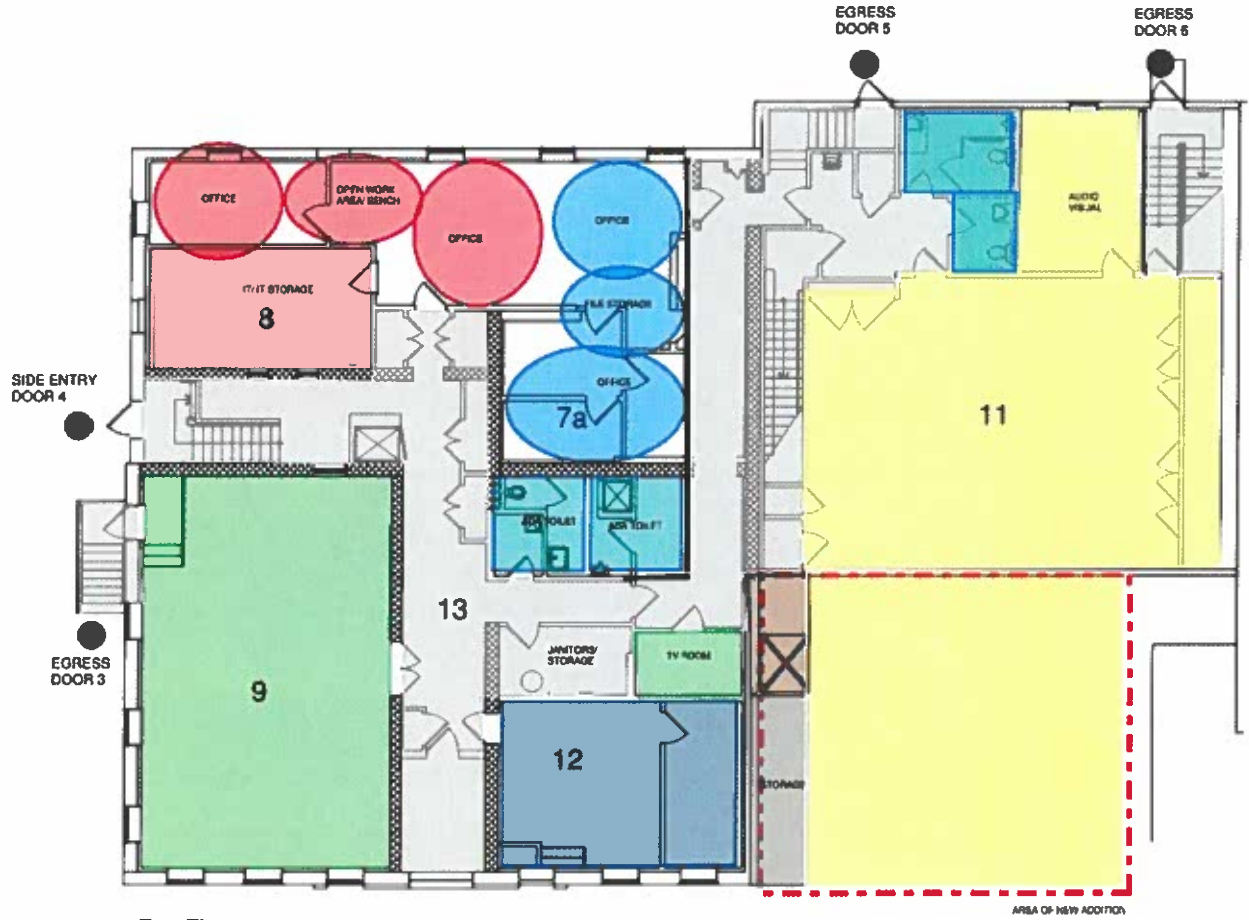
Proposed Basement Level

- 7a. Finance (water moved to first floor)
- 8. IT Department
- 9. Board of Selectman Meeting Room
- 10. Trustee Office (moved to first floor)
- 11. Buxton Meeting Room
- 12. Break Room
- 13. Circulation and Support

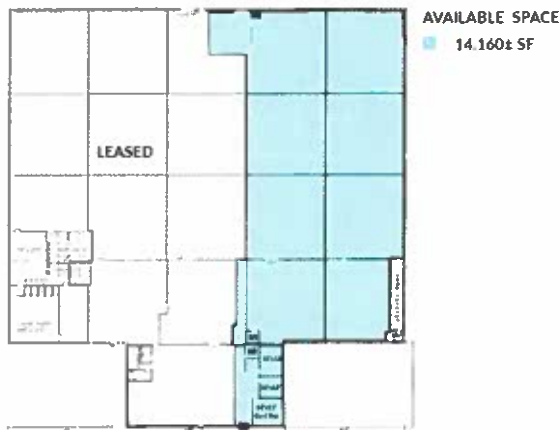
FLOOR PLAN

5 Flagstone Drive is a 25,400± SF industrial warehouse building with the entire space available for lease. Built in 1976, the building features 16' warehouse clear height, four loading docks and two 8'x10' drive-in doors. The building is serviced by municipal water & sewer and is heated by natural gas. The office space is fully air-conditioned. There are 52 parking spaces.
